September 19, 2006

Inspection Report

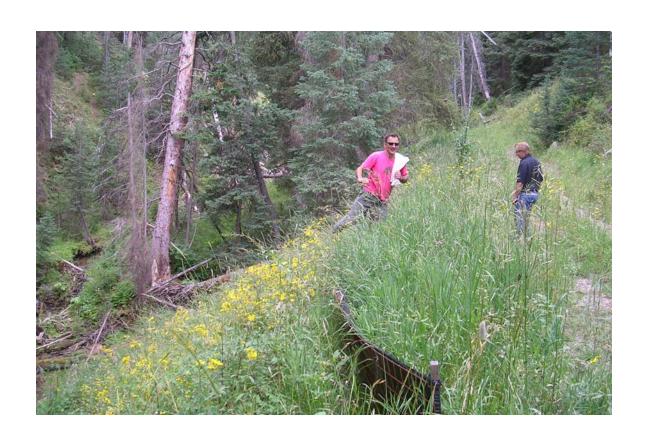
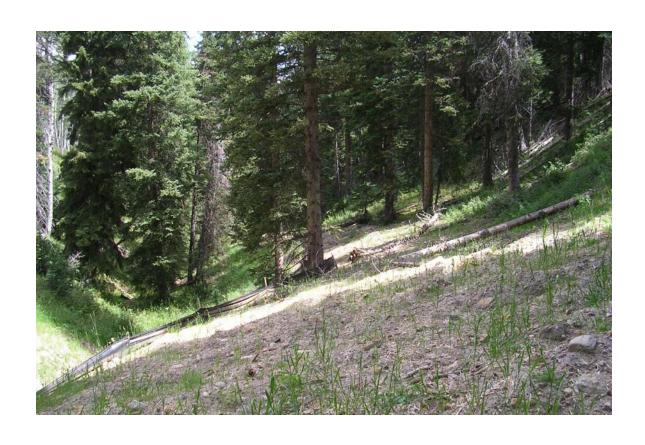
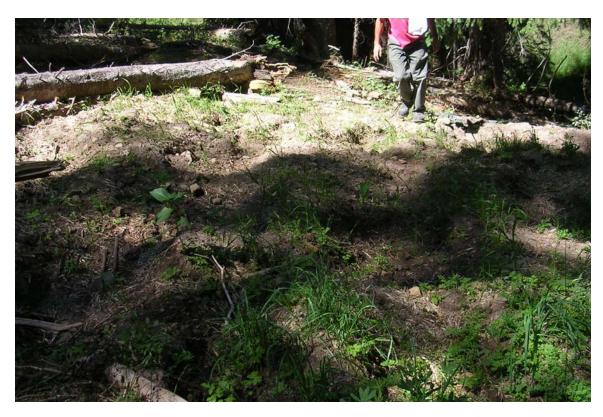
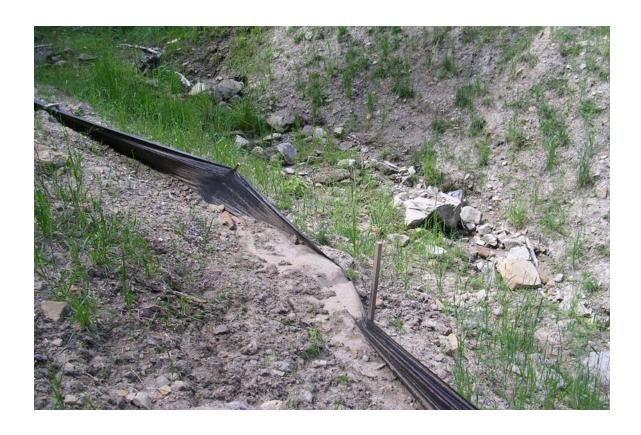
Last summer the permittee, DOGM, and the US Forest Service agreed upon a plan to recontour the Right Fork road. We inspected the South Fork reclamation which was re-graded in August 2005 to provide better reclamation of the right fork road, along which topsoil had been stored during operations of Mine #1 portals. The intial reclamation work had left a road cut that was unsatisfactory to the Division and the USFS. During this inspection, we noted that the vegetation along the road from the pump house to the Right Fork was providing good cover, although no additional seeding or grading was done after the traffic disturbance during the re-grading last year. Some thistle plants were noted along the road., but swales and silt fences were well vegetated. The creek below was running clear. Along the road to the Right Fork (the area where major regrading was done) varied in ground cover. The main reason was the soil type. Where topsoil (dark brown) was on the surface, vegetation did well. Vegetation was limited where subsoil was on the surface. (The subsoil had been stored in the "land bridge" across the stream. It was noticeably lighter in color and higher in clay content). Even so, there were some sprigs of grasses beginning to grow in the subsoil. This is the first growing season for the Right Fork. See photos.
